June 9, 2023

Historic Resources Survey for Hinge Neighbors Rochester, New York

The Historic Resources Survey for Hinge Neighbors has been prepared by The Landmark Society of Western New York, with funding provided by ESL Charitable Foundation and AARP.

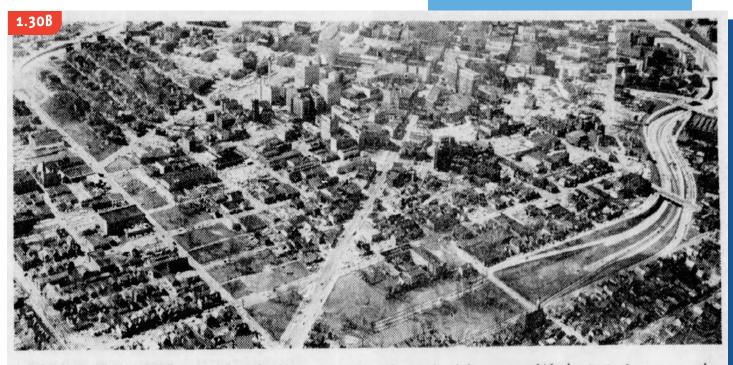
LOOPING THE LOOP-Air view looking over city shows final loop arc. Work starts in two weeks.

Figure 1.30B. 1964 aerial view of demolition for final segment of the Inner Loop, from Scio Street to George Street (near present-day Strong Museum); 164 structures were razed for this segment, including many residences and businesses in the survey area. Source: Democrat and Chronicle.

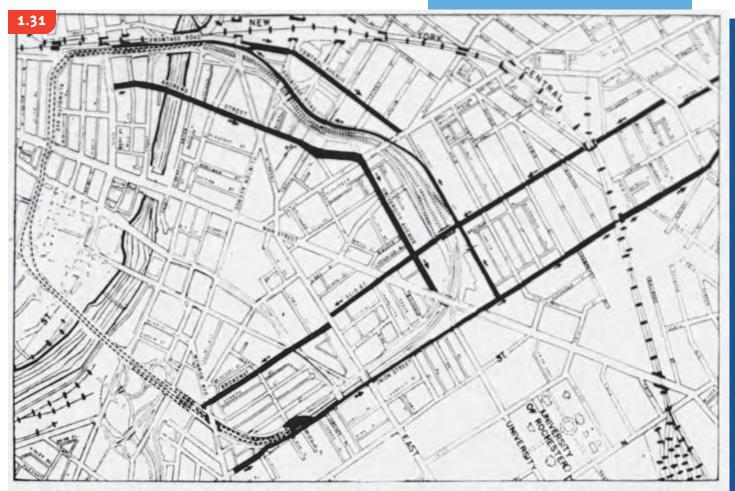
ONE-WAY PATTERN — Motorists will get on, off Inner Loop more quickly under one-way street program shown on map, says city traffic chief, Eugene Simm. First change will be today, when Scio Street

will be for southbound traffic only between Lyndhurst and Main streets. Dotted portion of Loop is scheduled to open today. Only one segment, Scio Street to George Street, remains to be completed.

Figure 1.31. 1962 map from a Democrat and Chronicle noting the completion of the Inner Loop segment from the River to Scio Street, depicting disruptive traffic changes in adjacent neighborhoods to smooth traffic flow. Source: Democrat and Chronicle.

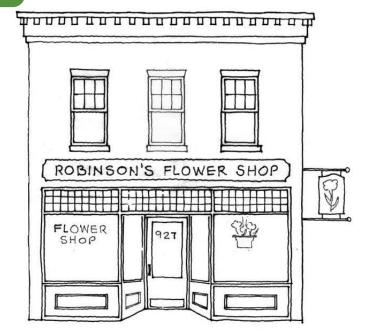
2.2

An example of a traditional storefront with transparent storefront and transom windows.

"**Priority Level 2**" recommendations are actions that would be nice to undertake at a future date, if conditions allow, i.e. if the owner is interested and has the financial resources to take such action. For commercial buildings, this most often includes restoring the first floor to a traditional storefront form with display windows, transoms, and bulkhead (*Figure 2.2*).

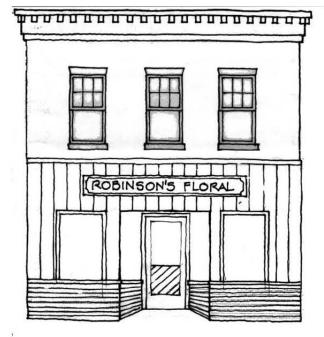
An example of a storefront that has been modified to reduce its transparency and mask some of its historic architectural features. These types of historically inappropriate modifications can be found on several buildings in the study area.

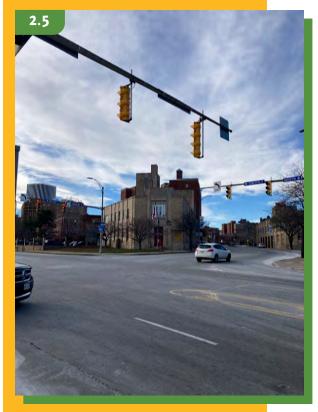
Nearly all of the historic buildings around this intersection have been demolished, and large-scale municipal and commercial buildings have taken their place. Across the street, at the corner of Andrews Street and North Chestnut Street are the 1936 Art Deco Rochester Fire Department firehouse and former Maintenance and Communications Buildings.

Rochester Fire Department at the corner of Andrews Street and North Chestnut Street

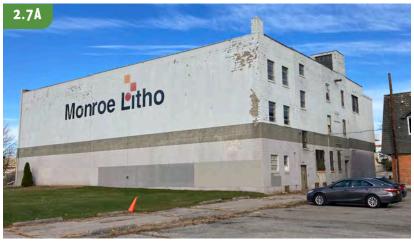
37-59 Delevan Street			
		HISTORIC ADDRESS	218-228 North Street (North Side Furniture); 10 University Avenue (Monroe Litho)
CURRENT OCCUPANT	Unknown	DATE OF CONSTRUCTION	1920, 1930, 1950, 1955, 1960, 1986
BUILDING TYPE	Industrial / Office complex	ZONING	C-2 Community Center
BUILDING & SITE DESCRIPTION	The former Monroe Litho / North Side Furniture building is a three-story, early 20th century brick mixed-use industrial building. It was originally constructed as a smaller commercial building with traditional street-level commercial storefronts. As a furniture store, the building was divided into four bays (or sections). Two additional buildings were added to the south end of the building to expand the size to eight total bays. The floor levels are delineated with decorative brick cornices and belt courses. Historic window openings have been filled in with (non-historic) glass block or smaller window openings. The ground level storefronts on North Street have been filled in with concrete and are no longer functioning as public facing commercial spaces. Due to these alterations, the building bears little resemblance to its historic appearance.

STATEMENT OF SIGNIFICANCE	 37-59 Delevan Street is one of the few remaining examples of large scale construction associated with the North Street commercial corridor that existed prior to the construction of the Inner Loop. The structure was originally utilized by North Side Furniture House, a 40,000 square foot family owned business. North Side was one of the city's largest home furnishing stores. It opened in 1904 and remained at this location until the 1990s. The business was an important part of the community with a sales floor dedicated to pricing furniture for primarily lower income clientele. The building was slated for demolition in 1992 before being taken over by the neighboring Monroe Litho Inc., which ceased operations in the 2010s. 		
RECOMMENDATIONS	This property does not retain any significant historic character or value, rather, it is an opportunity to restore historic development patterns in the node, once the existing buildings no longer serve a purpose.

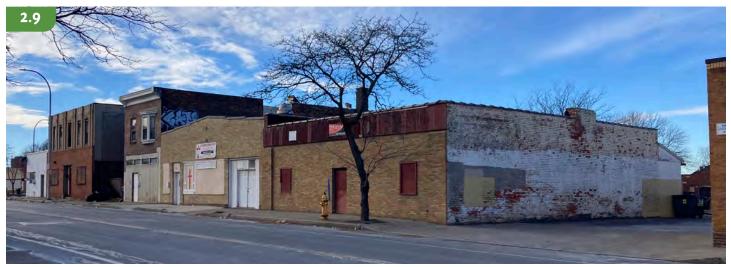
325-351 North Street, view facing south

325-327 North Street			
		HISTORIC ADDRESS	325-327 North Street
CURRENT OCCUPANT	Studio	DATE OF CONSTRUCTION	c.1935
BUILDING TYPE	Historic gas/service station	ZONING	C-2 Community Center
BUILDING DESCRIPTION	325-327 North Street is a utilitarian, one story, painted brick commercial building with an entrance facing the Hudson / North Street intersection. Although it appears to retain its overall historic form, it does not appear to retain any historic detailing from its original use as a service/gas station.		
STATEMENT OF SIGNIFICANCE	This lot was once home to a Shell gas station. Although historic service/gas stations can be architecturally and historically significant, this property does not appear to retain any detailing that would render it so. Nonetheless, it is significant as an existing building that contributes to the North Street streetscape.		
RECOMMENDATIONS	Restore neighborhood serving business, such as grocer or corner store, to this building.

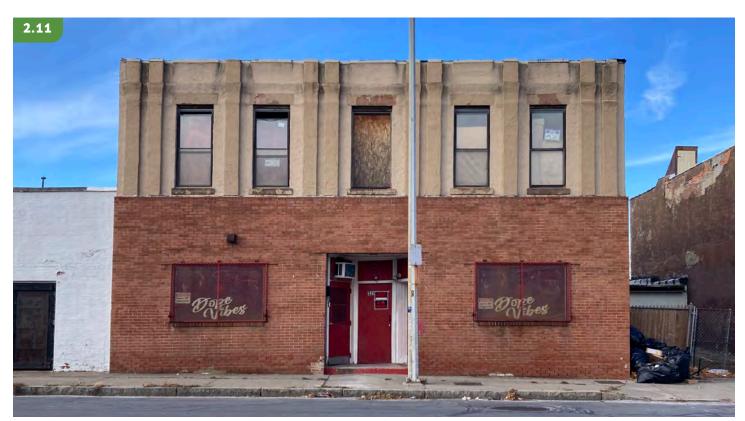
329-333 N	329-333 North Street		N/A
CURRENT OCCUPANT	Unknown DATE OF CONSTRUCTION C.1890		c.1890
BUILDING TYPE	Historic commercial building	ZONING	C-2 Community Center
BUILDING DESCRIPTION	329-333 North Street is a two story, historic commercial building. The first floor facade is clad in brick and appears to date to the mid-20th century. Second story facade has been covered in stucco, obscuring historic pilasters and cornice. Original window openings intact.		
STATEMENT OF SIGNIFICANCE	Although it has experienced some significant alterations over time, this building is an example of an extant historic, small scale commercial building that retains its overall form. Newspaper articles report a two-alarm fire in the building in 1953, which may explain some of the changes to the facade.		
RECOMMENDATIONS	Priority Level 1: Retain building as an important contributor to the North Street streetscape. Priority Level 2: If/when practical, consideration should be given to returning the first floor facade to a more traditional storefront form with display windows. While removing the second floor stucco might reveal notable architectural details, it may note be possible to remove it without damaging the brick beneath.

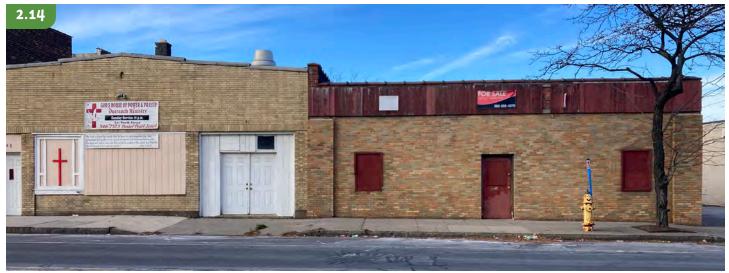
347-351 North Street (on right)

347-351 North Street			
		HISTORIC ADDRESS	N/A
CURRENT OCCUPANT	N/A	DATE OF CONSTRUCTION	c.1900
BUILDING TYPE	Historic commercial building	ZONING	C-2 Community Center
BUILDING DESCRIPTION	347-351 North Street is a historic, single story, brick commercial building. Facade has been significantly altered from its original appearance and appears to have a later brick veneer. Single door entrance and two windows that have been covered over with plywood.		
STATEMENT OF SIGNIFICANCE	Although it has experienced significant alterations over time in order to accommodate contemporary uses, this building is an example of an extant historic, small scale commercial building that retains its overall form.		
RECOMMENDATIONS	Priority Level 1: Retain building as an important contributor to the North Street streetscape. Priority Level 2: If/when practical, assess options for re-designing facade to provide greater interaction with the street.

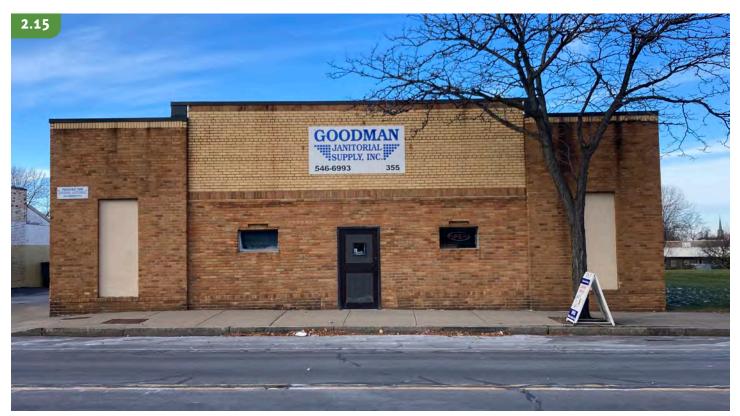
355 North Street			
		HISTORIC ADDRESS	N/A
CURRENT OCCUPANT	N/A	DATE OF CONSTRUCTION	1947
BUILDING TYPE	Historic commercial building	ZONING	C-2 Community Center
BUILDING DESCRIPTION	355 North Street is a one story brick commercial building with a symmetrical façade featuring a single entrance centered between two small single pane windows and two larger door-sized openings which have been covered over. The central portion of the facade likely had significantly larger window and door openings originally.		
STATEMENT OF SIGNIFICANCE	This parcel was once the home of the German Methodist Episcopal Church. The current building was constructed in 1947 as an automotive repair shop. Although it has experienced some alterations over time in order to accommodate contemporary uses, this building is an example of an extant historic, small scale commercial building that retains its overall form.		
RECOMMENDATIONS	Priority Level 1: Retain building as an important contributor to the North Street streetscape. Priority Level 2: If/when practical, assess options for re-designing facade to provide greater interaction with the street.

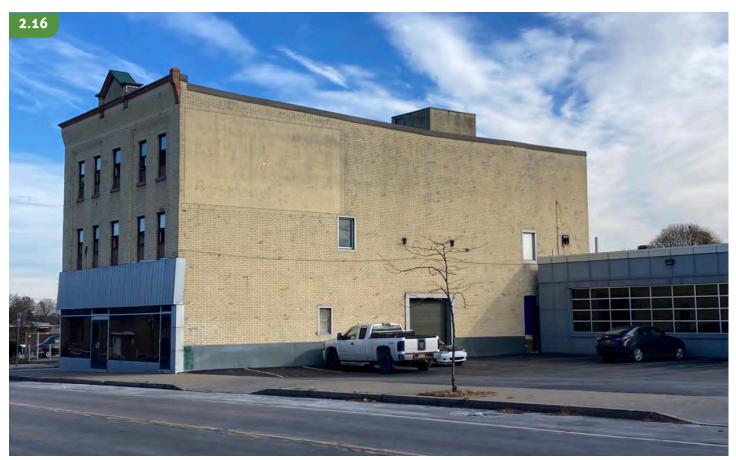
368-372 North Street			
		HISTORIC ADDRESS	368-372 North Street
CURRENT OCCUPANT	N/A	DATE OF CONSTRUCTION	c.1888
BUILDING TYPE	Historic commercial building	ZONING	C-2 Community Center
BUILDING DESCRIPTION	368-372 North Street is a three story historic, blonde brick commercial building. It features a centered pediment on façade. First floor contains a modern replacement storefront with large display windows. Upper story window openings have been downsized. Evidence of former painted sign in third story of south elevation.		
STATEMENT OF SIGNIFICANCE	Although it has experienced some alterations, this building is an intact example of a typical three story commercial building found on commercial spines throughout the 16th Ward neighborhood (and on commercial spines throughout much of the city).		
RECOMMENDATIONS	Priority Level 1: Retain building as an important contributor to the North Street streetscape. Priority Level 2: If/when practical, redo/reopen street level storefronts. A traditional storefront form with display windows encourages pedestrian activity.

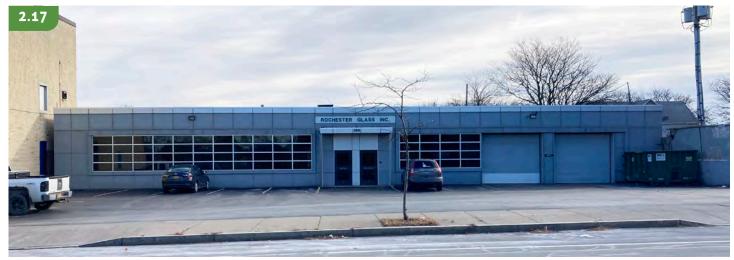
360 North Street			
		HISTORIC ADDRESS	350-366 North Street
CURRENT OCCUPANT	Rochester Glass, Inc	DATE OF CONSTRUCTION	1956
BUILDING TYPE	Historic Commercial/Industrial Building	ZONING	C-2 Community Center
BUILDING DESCRIPTION	360 North Street is a one story, Mid-Century Modern style commercial/industrial building. It features horizontal aluminum and plate glass windows and a stylized Mid-Century style front entrance. The building is set back from the street to provide parking.		
STATEMENT OF SIGNIFICANCE	360 North Street is a distinctive, intact, and rare example of mid-twentieth century commercial architecture. It was the home of printing company, Rochester Monotype beginning in 1956. A 1936 plat map indicates that this lot was the site of the Woodward Playground, which replaced three brick commercial buildings sometime after 1910.		
RECOMMENDATIONS	Retain building and its Mid-Century Modern detailing.

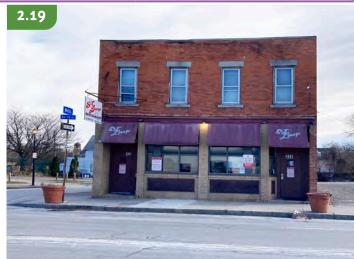
³²⁸⁻³³⁰ North Street

328-330 North Street			
		HISTORIC ADDRESS	328-330 North Street
CURRENT OCCUPANT	S&T Lounge Restaurant	DATE OF CONSTRUCTION	c.1860 At least 1875, possibly earlier
BUILDING TYPE	Historic commercial building	ZONING	C-2 Community Center
BUILDING DESCRIPTION	 328-330 North Street is a two story brick, historic commercial building with an adjacent parking lot. The storefront is likely a mid-20th century (or later) alteration. Original window openings remain intact. Front section of the building has lost its cornice, however, the historic cornice remains on the rear wing facing Weld Street. The south wall features a large mural by Sydney G. James (part of the 2022 Wall/Therapy project) called ""Homage to the Blueprint"" which depicts an energetic singer in the foreground and two silhouettes of a jazz trumpeter and a dancer in the background. 310-326 North Street is a large gravel parking lot located between the S&T Lounge and an apartment building next door. It appears to be in regular use.

STATEMENT OF SIGNIFICANCE	Although it has experienced some alterations to its storefront and appears to have lost its cornice, this building is an intact example of a typical small scale, two story commercial building found on commercial spines throughout the 16th Ward neighborhood (and on commercial spines throughout much of the city). This building is one of the oldest remaining commercial buildings in this node and along this section of North Street. S&T Lounge is one of the few sit-down bar / restaurants in the neighborhood. The building housed restaurant (Albert's Grill) in the 1940s, suggesting that it may have been in continuous use as a restaurant.		
RECOMMENDATIONS	Priority Level 1: Retain building as an important contributor to the North Street streetscape. Priority Level 2: If/when practical, redo/reopen street level storefronts. A traditional storefront form with display windows encourages pedestrian activity.

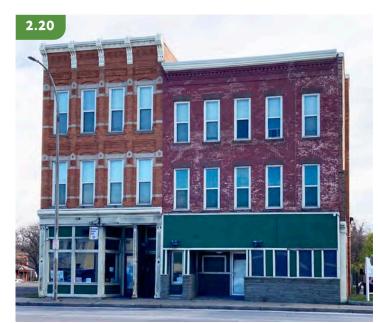
300 (at right)-308 North Street

300-308 North Street			
		HISTORIC ADDRESS	300-304 and 306-308 North Street
CURRENT OCCUPANT	Unknown DATE OF CONSTRUCTION		c.1880
BUILDING TYPE	Historic commercial building	ZONING	C-2 Community Center
BUILDING DESCRIPTION	300-308 consists of two brick, three-story historic commercial buildings with storefronts at street level and upper stories. 300 North Street (at right in image) has a distinctive mid to late 20th century stone storefront with aluminum framed windows and 308 North Street features an ornate cast iron storefront with decorative brick and stonework on the upper stories.		
STATEMENT OF SIGNIFICANCE	Both buildings are excellent, intact examples of a typical small scale, two-three story commercial building found on commercial spines throughout the 16th Ward neighborhood (and on commercial spines throughout much of the city). 308 is particularly notable for its largely intact historic storefront. Both buildings are notable for retaining the original window openings on the upper floors. Lastly, both buildings are also several decades older than the majority of the historic commercial buildings in this node, most of which date to the early 20th century. Businesses that occupied these buildings included: Buddy's Casina at 302 or 304 (at least 1946-mid 1960s, according to 1940s business directory and historical accounts described in Section 1), Hattie M. Martin Beauty Shop (1940s business directory), a restaurant (1988 photo on previous page), International Order of Odd Fellows (1935 plat map)

RECOMMENDATIONS	Priority Level 1: Retain both buildings. Retain intact historic storefront at 308. Priority Level 2: If/when practical, redo/reopen street level storefront at 300. A traditional storefront form with display windows encourages pedestrian activity.

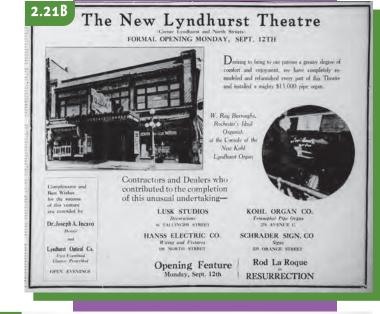
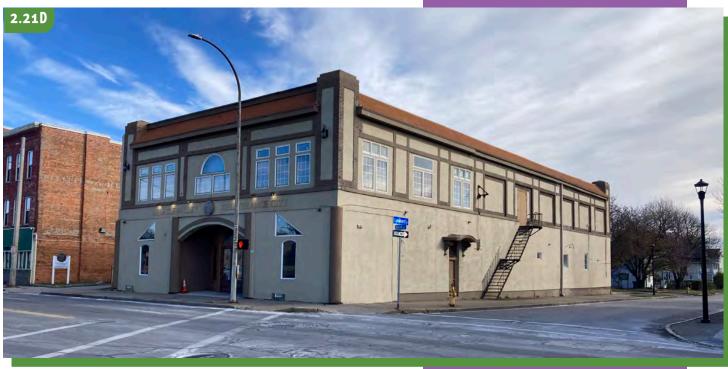
290-292 North Street

290-292,294-298			
North Street		HISTORIC ADDRESS	290-292 and 294-298 North Street (Lyndhurst Theater, World Theater)
CURRENT OCCUPANT	Miracle Valley Deliverance City Church	DATE OF CONSTRUCTION	ca. 1912 (parking/drive paved 1960)
BUILDING TYPE	Historic commercial building	ZONING	C-2 Community Center
BUILDING DESCRIPTION	 Miracle Valley Deliverance City is located in the former World Theatre building. This two story early Art Deco style building has had many alterations to the facade including the removal of the marquee and alteration and infill of historic window and door openings. The upper story is relatively unaltered except for window replacements, but the street level façade has been changed significantly. 294-298 North Street is a parking lot used by the Miracle Valley Deliverance City Church located next door. It extends around the back of the church, as well as the building next door, 300-308 North Street.

RECOMMENDATIONS	Although alterations to the window and door openings have significantly changed the building's appearance, the overall form and design is still distinct and recognizable. If a future owner were interested, original architectural elements could be restored, though this would require a substantial investment.

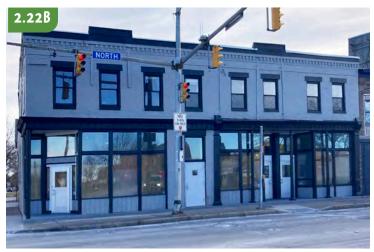
280-286 North Street (present day)

280-286 North Street			
		HISTORIC ADDRESS	N/A
CURRENT OCCUPANT	Unknown	DATE OF CONSTRUCTION	1890,1920
BUILDING TYPE	Historic commercial building	ZONING	C-2 Community Center
BUILDING DESCRIPTION	280-286 is a two story brick building with cast iron columns at the street level. The entire building has recently been repainted and the door and window openings have been uncovered and reopened. The storefronts are either in use or available to rent.		
STATEMENT OF SIGNIFICANCE	 This building is located on a triangle of land bordered by North, Cumberland and Lyndhurst Streets. This island was created when the Inner Loop was originally constructed and buildings on the same block to the south of 270-274 North Street were demolished for this purpose. This building is an intact example of a typical small scale, two story commercial building found on commercial spines throughout the 16th Ward neighborhood (and on commercial spines throughout much of the city). This building is a good example of how first floor storefront forms can be restored, with the goal of encouraging pedestrian activity and activating the streetscape. Revealing door and window openings that were previously covered with plywood and giving the whole building a new coat of paint has made a huge difference. This building was previously boarded up and as a result looked abandoned and uninhabitable.

RECOMMENDATIONS	Retain building as an important contributor to the North Street streetscape.

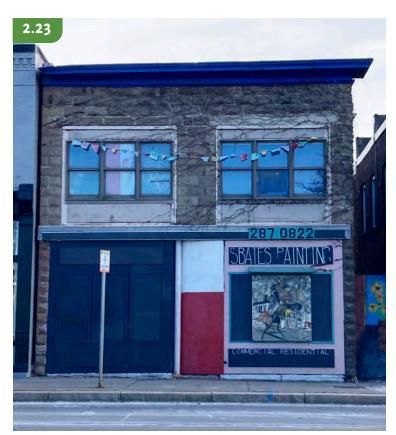
276-278 North Street			
		HISTORIC ADDRESS	N/A
CURRENT OCCUPANT	Unknown	DATE OF CONSTRUCTION	c.1905
BUILDING TYPE	Historic commercial building	ZONING	C-2 Community Center
BUILDING DESCRIPTION	276-278 is constructed of decorative, cast concrete blocks that mimic rustic stone. The street level storefront has been covered up with plywood and painted. Second floor window openings have been downsized from their original size.		
STATEMENT OF SIGNIFICANCE	This building is located on a triangle of land bordered by North, Cumberland and Lyndhurst Streets. This island was created when the Inner Loop was constructed and buildings to the south of 270-274 North Street were demolished for this purpose. Although it has experienced some alterations, this building is an intact example of a typical small scale, two story commercial building found on commercial spines throughout the 16th Ward neighborhood (and on commercial spines throughout much of the city).

RECOMMENDATIONS	Priority Level 1: Retain building as an important contributor to the North Street streetscape. Priority Level 2: If/when practical, redo/reopen street level storefronts. A traditional storefront form with display windows encourages pedestrian activity.

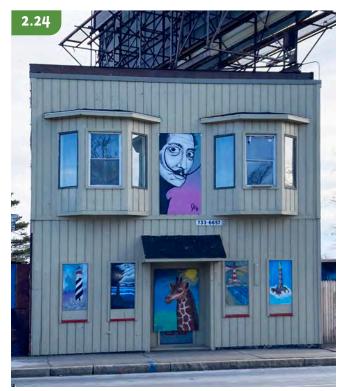
270-274 N	270-274 North Street		N/A
CURRENT OCCUPANT	Unknown	DATE OF CONSTRUCTION	c.1905
BUILDING TYPE	Historic commercial building	ZONING	C-2 Community Center
BUILDING DESCRIPTION	270-274 North Street is a two story brick building. Façade is covered with non-historic vertical wooden siding. Many of the original window openings are covered, particularly on the ground floor, and there is a significant amount of cheerful decoration in the form of painting on the walls and window inserts. On the building's south side, is a concrete-covered outdoor space.		
STATEMENT OF SIGNIFICANCE	This building is located on a triangle of land bordered by North, Cumberland and Lyndhurst Streets. This island was created when the Inner Loop was originally constructed and buildings to the south of 270-274 North Street were demolished for this purpose. Although it has experienced some alterations over time in order to accommodate contemporary uses, this building is an example of an extant historic, small scale commercial building that retains its overall form.

RECOMMENDATIONS	Priority Level 1: Retain building as an important contributor to the North Street streetscape. Priority Level 2: If/when practical, redo/reopen street level storefronts. A traditional storefront form with display windows encourages pedestrian activity.

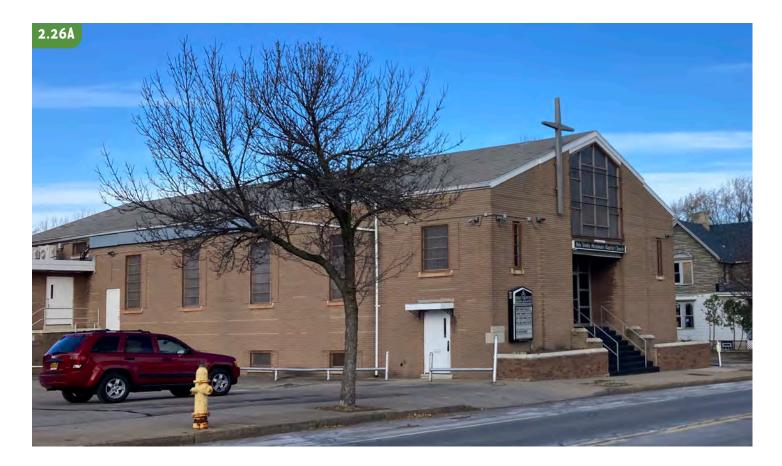
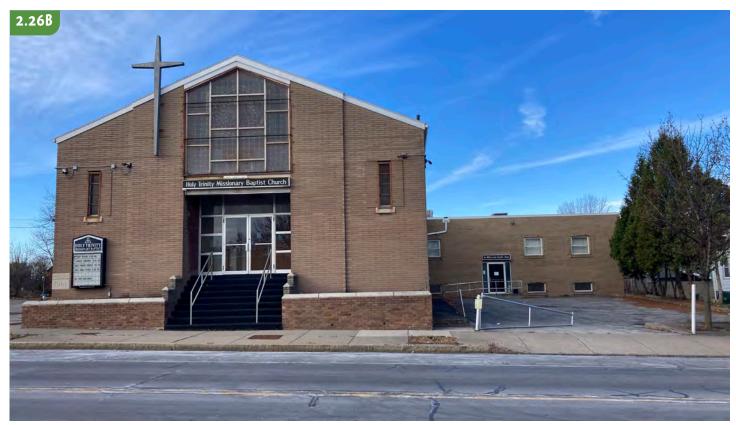
401 North Street 401 North Street (North Street **HISTORIC ADDRESS** Methodist Episcopal Church) DATE OF Holy Trinity Missionary Baptist **CURRENT OCCUPANT** 1961 CONSTRUCTION Church **BUILDING TYPE** ZONING Historic house of worship C-2 Community Center Mid-Century Modern style church, constructed of tan brick, with minimal architecture BUILDING ornamentation. The building has a low-pitched roof, geometric stained glass windows on the DESCRIPTION facade and a large cross set to the left of the roof peak. This Mid-Century Modern style church is highly significant due to its association with Thomas W. Boyde Jr., Rochester's first Black architect. Completed in 1961, Holy Trinity Baptist Church is one of a small handful of houses of worship designed by Boyde. Over a career spanning nearly fifty years in Rochester, Mr. Boyde designed over 700 buildings of which over 300 STATEMENT OF still stand today. His broad body of work includes: bridges, Monroe Community Hospital, SIGNIFICANCE restaurants, car dealerships, factories, offices, apartments, and single family homes. He was especially well known for his sleek mid-century modern ranch homes that dot many suburban streets throughout our region. Priority Level 1: The best way to ensure the long term preservation of this building is for it to remain in active use. Priority Level 2: Consult with congregation to determine if they would like preservation / fundraising assistance to care for the building. RECOMMENDATIONS Priority Level 3: Consult with congregation to inquire if they would be interested in listing the building in the National Register of Historic Places. This is an honorary program that does not place restrictions on private property owners.

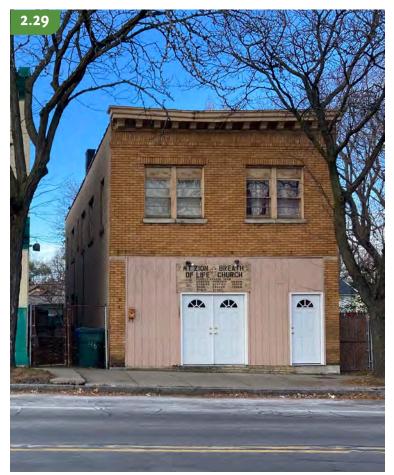
427-429 North Street		HISTORIC ADDRESS	N/A
CURRENT OCCUPANT	Church	DATE OF CONSTRUCTION	c.1915
BUILDING TYPE	Historic commercial building	ZONING	C-2 Community Center
BUILDING DESCRIPTION	427-429 North Street is a small, two story, historic brick commercial building. The storefront has been infilled.		
STATEMENT OF SIGNIFICANCE	Although it has experienced some alterations, this building is an intact example of a typical small scale, two story commercial building found on commercial spines throughout the 16th Ward neighborhood (and on commercial spines throughout much of the city).		
RECOMMENDATIONS	Priority Level 1: Retain building as an important contributor to the North Street streetscape. Priority Level 2: If/when practical, redo/reopen street level storefront. A traditional storefront form with display windows encourages pedestrian activity.

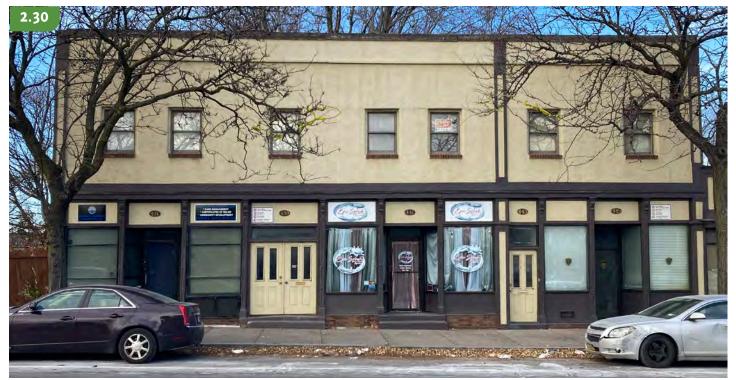
437-441 North Street (445 at far right)

437-441 North Street		HISTORIC ADDRESS	N/A
CURRENT OCCUPANT	Multi-tenant	DATE OF CONSTRUCTION	c.1875
BUILDING TYPE	Historic commercial building	ZONING	C-2 Community Center
BUILDING DESCRIPTION	 437-445 North Street is a two story brick commercial building. The first floor storefronts retain their historic form (recessed entrances and divisions across the facade) as well as cast iron storefront columns, display windows, and covered transom windows. Cornice has been altered/removed. Second floor appears to have later parging/stucco that may be obscuring the full size of the original window openings, which appear to have been downsized. 		
STATEMENT OF SIGNIFICANCE	Although it has experienced some alterations, this building is an intact example of a typical small scale, two story commercial building found on commercial spines throughout the 16th Ward neighborhood (and on commercial spines throughout much of the city). This building is particularly notable for its largely intact historic storefronts.

RECOMMENDATIONS	Priority Level 1: Retain building as an important contributor to the North Street streetscape. If at all possible, retain and restore historic storefronts. Priority Level 2: Rehabilitate upper floor, restore original window openings.

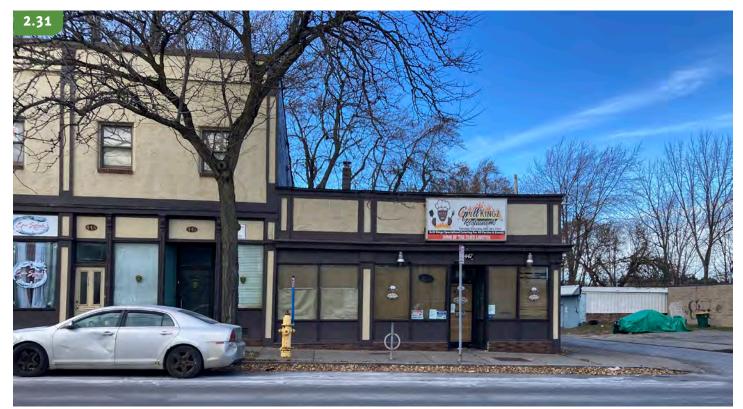
445-447 North Street (445 at far left)

445-447 N(445-447 North Street		441, 445, 447 North Street
CURRENT OCCUPANT	Grill Kingz restaurant	DATE OF CONSTRUCTION	A building has existed on this site since at least 1875. Further research is needed to determine if this building dates to that time period.
BUILDING TYPE	Historic commercial building	ZONING	C-2 Community Center
BUILDING DESCRIPTION	447 North Street is a one story historic commercial building that is a later addition to its adjoining neighbor to the south. 445 North Street encompasses the northernmost section of the adjoining two-story building. Although the storefront at 447 is a modern replacement, it retains a traditional storefront form with display windows. One story, utilitarian, cast concrete block structure with over head garage doors attached at rear of building.		
STATEMENT OF SIGNIFICANCE	Although it has experienced some alterations, this building is an intact example of a typical small scale, one story commercial building found on commercial spines throughout the 16th Ward neighborhood (and on commercial spines throughout much of the city).

RECOMMENDATIONS	Retain building as an important contributor to the North Street streetscape.

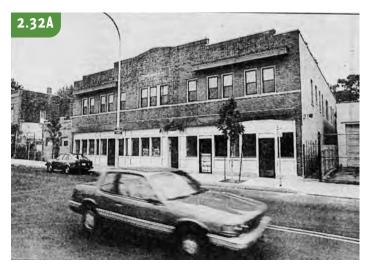
463-473 North Street			
		HISTORIC ADDRESS	N/A
CURRENT OCCUPANT	Ellison Commons	DATE OF CONSTRUCTION	1920
BUILDING TYPE	Historic commercial building	ZONING	C-2 Community Center
BUILDING DESCRIPTION	463-473 North Street is a historic, two story, brick commercial building consisting of multiple storefronts at street level and a symmetrical second floor, with a stepped parapet roof. Modern storefronts maintain traditional historic storefront components.		
STATEMENT OF SIGNIFICANCE	 The building is known most recently as Ellison Commons. In the 1950s, the building was home to Sherman Battery and Auto Supply Co., Inc. The building was rehabilitated in 1987 by local contractor, Henry James, as part of a neighborhood and City-led effort to revitalize properties along North Street Since that time, the facade has lost some details, including narrow, decorative roof overhangs with clay tile roofs above two sets of second floor windows and a sign panel centered above the second story (remnants of which are visible today). 463-473 North Street is an excellent, intact example of a typical two-three story commercial building found on commercial spines throughout the 16th Ward neighborhood (and on commercial spines throughout much of the city).

RECOMMENDATIONS	Retain building as an important contributor to the North Street streetscape.

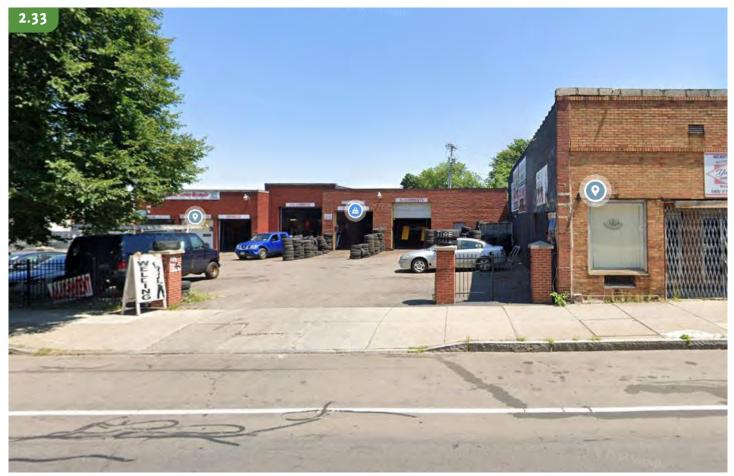
462-466 NG	462-466 North Street		N/A
CURRENT OCCUPANT	Tire/automotive	DATE OF CONSTRUCTION	At least a portion of this building existed by 1935. Later additions likely date to the 1950s.
BUILDING TYPE	Historic gas/service station	ZONING	C-2 Community Center
BUILDING & SITE DESCRIPTION	462-466 North Street is a one story, utilitarian, brick auto body shop with an office, five garage bays of varying sizes, and a large parking lot. The building is set back from the street, with the parking lot in front. Originally, at least a portion of the building was clad in stucco.		
STATEMENT OF SIGNIFICANCE	As early as 1943 and as late as 1973, this property was home to Pat Fraina's Sinclar / Fraina's Service. Historic maps indicate that a portion of the service station existed as early as 1935, making this property a relatively early example of an automotive service station.		
RECOMMENDATIONS	Retain building as an important contributor to the North Street streetscape.

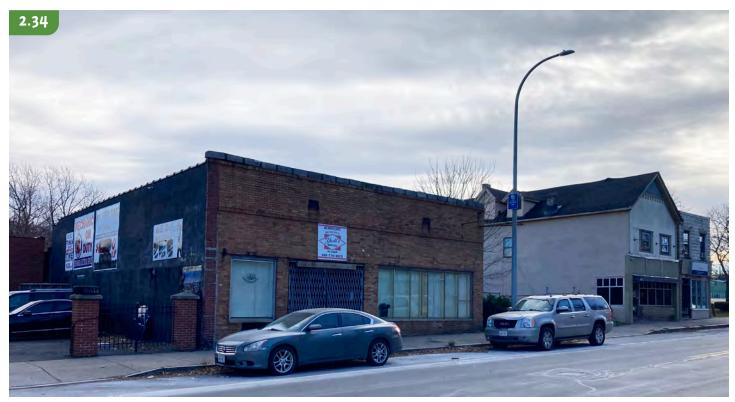
450-452 North Street			
		HISTORIC ADDRESS	438-444 North Street (unverified)
CURRENT OCCUPANT	Wholesale supplier	DATE OF CONSTRUCTION	1940
BUILDING TYPE	Single use small building	ZONING	C-2 Community Center
BUILDING DESCRIPTION	450 North Street is a two story brick commercial building. The storefront features large plate glass windows and much of the brick is in need of repair.		
STATEMENT OF SIGNIFICANCE	Although it has experienced some alterations over time in order to accommodate contemporary uses, this building is an example of an extant historic, small scale commercial building that retains its overall form.		
RECOMMENDATIONS	Retain building as an important contributor to the North Street streetscape.

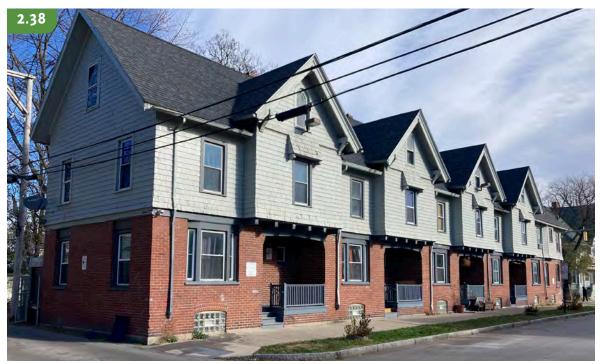
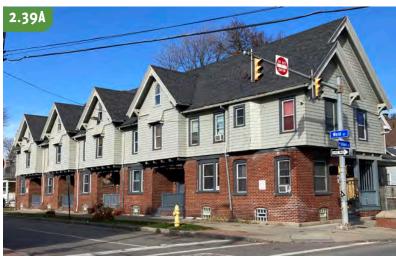
163 N. Union Street

163 North Union Street			
		HISTORIC ADDRESS	142-150 Weld Street
CURRENT OCCUPANT	Private residences	DATE OF CONSTRUCTION	c.1910
BUILDING TYPE	Historic multi-family residence / "Rochester Rowhouse"	ZONING	Marketview Heights Urban Renewal District / R-2 Medium Density Residential
BUILDING DESCRIPTION	This multifamily residence represents a building type that seems to be unique to Rochester and does not exist in other upstate NY cities. This building type does not yet have a definitive name, however, it is sometimes informally referred to as a "Rochester Rowhouse." There are at least three or four different examples of this type of dwelling in the northeast quadrant of Rochester, but this is the only one located in this neighborhood. The apartment building is two-and-one-half stories high with Queen Anne and Craftsman style detailing, a brick first story, and a cedar shingle-clad second story. It consists of eight townhouse style apartments. It was constructed as a six-unit building, but has undergone interior renovations to expand the number.

STATEMENT OF SIGNIFICANCE	Constructed between 1900 and 1910. This building type proliferated in other city neighborhoods as developers attempted to meet the needs of an early 20th century real estate boom and increased demand for urban housing. 163 N. Union is the only remaining example of this building type in the 16th Ward (one other similar structure was built at the corner of Scio and Woodward Streets, however, this building was demolished and the lot remains vacant). It is architecturally significant as an example of this building type. The building underwent rehabilitation in 1990s.		
RECOMMENDATIONS	This building type could provide inspiration for modern infill development that meets residents' desires for human-scaled housing.

Node 4 contains two unique and architecturally significant buildings--163 N. Union Street and 153-155 N. Union Street A high priority should be placed on the continued stewardship and preservation of these important anchor buildings. Combined with the large residence at 160 N. Union Street (not surveyed) and recent curb bumpouts, these historic buildings create an appealing feeling of urban density and walkability at this intersection.

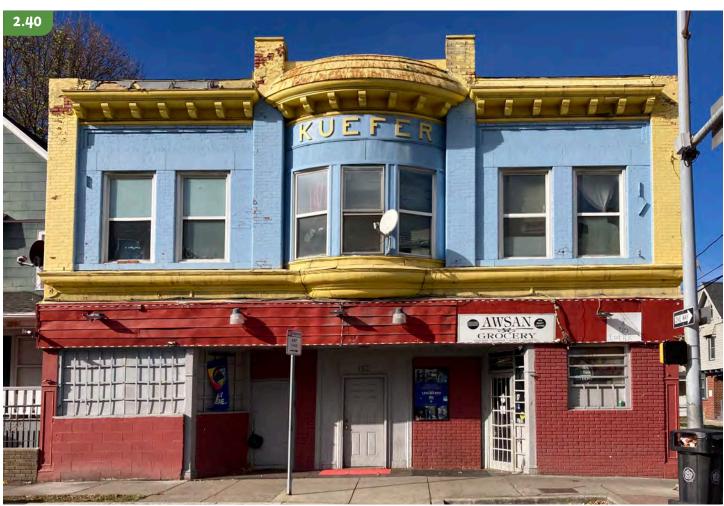
153-155 N. Union Street

HISTORIC ADDRESS	151-155 North Union Street
CURRENT OCCUPANT	Awsan Grocery Store	DATE OF CONSTRUCTION	c.1900
BUILDING TYPE	Historic commercial building	ZONING	Marketview Heights Urban Renewal District / R-2 Medium Density Residential
BUILDING DESCRIPTION	Built sometime between 1888 and 1900, 153-155 North Union Street is a two story, brick, historic commercial building. The first floor houses a food market and is painted in a colorful red, yellow and pale blue color scheme. The storefront has been mostly infilled and the historic sign band has been covered. Large letters above the centered, second floor bay window read "KEUFER". The roofline cornice and bay window are particularly remarkable and unusual for this building type and scale. An elaborate memorial mural for Emilio Quintana (4/1/47 - 5/15/91) by Luis Zarate "Congo" is located on the northern side of the building, on

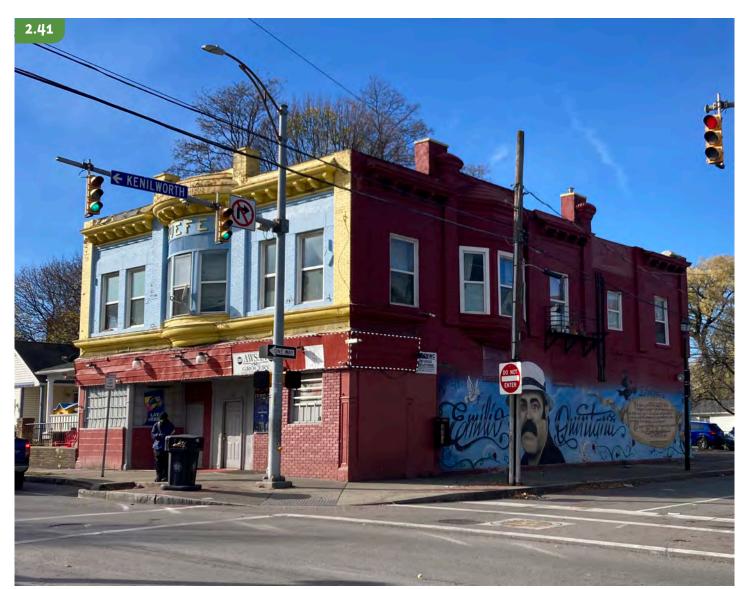
153-155 N. Union Street

Although it has experienced some alterations over time in order to accommodate contemporary uses, this building is an example of an extant historic, small scale commercial building that retains its overall form and many of its historic details.	
RECOMMENDATIONS Priority Level 2:	 Priority Level 1: Retain building as an important contributor to the N. Union Street streetscape. Priority Level 2: The building needs general maintenance including brickwork and repainting.	
Consult with ow	Consult with owner to inquire if they would be interested in listing the building in the National	
Register of Hist	Register of Historic Places. This is an honorary program that does not place restrictions on	
private property	private property owners. Priority Level 3: If/when practical, redo/reopen street level storefronts. A traditional storefront	
Priority Level 3:	form with display windows encourages pedestrian activity.

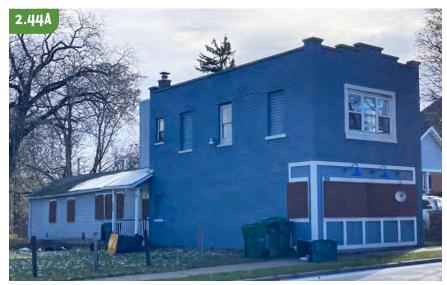
296 Scio Street			
		HISTORIC ADDRESS	N/A
CURRENT OCCUPANT	Unknown	DATE OF CONSTRUCTION	c.1915
BUILDING TYPE	Historic commercial building	ZONING	Marketview Heights Urban Renewal District / R-2 Medium Density Residential
BUILDING DESCRIPTION	296 Scio Street is a historic, two story, brick commercial building with a stepped parapet roof. All window and door openings have been retrofitted with new vinyl windows. The storefront has been altered from its historic appearance and at least partially infilled. One-story wood frame addition attached to rear elevation.		
STATEMENT OF SIGNIFICANCE	Pasquale Saraceno operated a grocery in this building as early as 1934 through at least 1945. Although it has experienced some alterations over time in order to accommodate contemporary uses, this building is an example of an extant historic, small scale commercial building that retains its overall form.		
RECOMMENDATIONS	Priority Level 1: Retain building as an important contributor to the Scio Street streetscape. Priority Level 2: If/when practical, redo/reopen street level storefronts. A traditional storefront form with display windows encourages pedestrian activity.

RECOMMENDATIONS	Priority Level 1: Retain building as an important contributor to the Scio Street streetscape. Priority Level 2: If/when practical, redo/reopen street level storefronts. A traditional storefront form with display windows encourages pedestrian activity. If/when practical, return second floor windows to their original size.

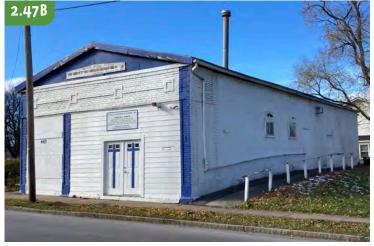
443-447 Scio Street			
		HISTORIC ADDRESS	443 Scio Street
CURRENT OCCUPANT	Unknown	DATE OF CONSTRUCTION	c.1920
BUILDING TYPE	Historic commercial building	ZONING	Marketview Heights Urban Renewal District / R-2 Medium Density Residential
BUILDING DESCRIPTION	443-447 Scio Street is a gable front brick rectangular plan building. There is decorative brickwork above the double door entrance and plain brick infill to the right. The gabled roof appears to be a later alteration; the building likely had a flat roof with parapet, typical of early 20th century, neighborhood-scale commercial buildings.		
STATEMENT OF SIGNIFICANCE	This building had a variety of uses throughout its early history: in the late 1920s it may have housed an ice cream parlor; by 1930 it housed the Scio Bakery Shop; by 1932, it served as the headquarters of the 16th Ward Roosevelt Democratic Club; by 1937 and continuing into the 1940s, it was the headquarters for the 16th Ward Republican Club; and by 1947, it housed a meat market run by Anthony Pellegrino. Although it has experienced some alterations over time in order to accommodate contemporary uses, this building is an example of an extant historic, small scale commercial building that retains its overall form.

RECOMMENDATIONS	Priority Level 1: Retain building as a Priority Level 2: If/when practical, r form with display windows encoura	edo/reopen street level s

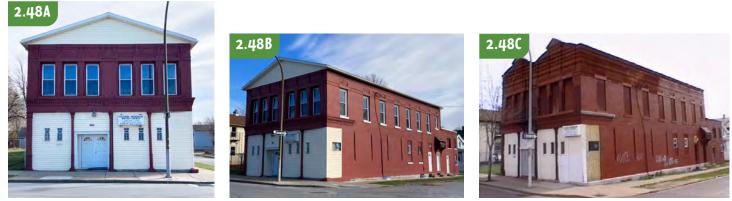
402 Scio Street (present-day)

402 Scio Street			
		HISTORIC ADDRESS	236 (1910) and 400 (1935) Scio Street
CURRENT OCCUPANT	Unknown	DATE OF CONSTRUCTION	c.1870
BUILDING TYPE	Historic commercial building	ZONING	Marketview Heights Urban Renewal District / R-2 Medium Density Residential
BUILDING DESCRIPTION	402 Scio Street is a historic, two story, brick commercial building. Although the storefront has been infilled with vinyl siding, it retains the historic cast iron Corinthian columns, decorative end post, and brick and metal storefront cornice. Roof shape has been altered. A 1995 image on the City's property information database shows the parapet cornice with elaborate decorative brickwork. The parapet was subsequently removed and replaced with a gabled roof.		
STATEMENT OF SIGNIFICANCE	Although it has experienced some significant alterations over time in order to accommodate contemporary uses, this building is an example of an extant historic, small scale commercial building that retains its overall form. The 1911-1912 Sanborn Maps indicates that the first floor was divided at the center with a saloon in the southern space and a store in the northern space. This building is also labeled 'Sausage Factory' on the same map (Sheet 134). Historic maps show a building on this site as early as 1875.

RECOMMENDATIONS	Since small storefront churches located in this type of building sometimes outgrow their spaces and move to other locations, it is always important to take into account the potential that the tenants of 402 Scio Street might change at some point in the future. In the event that the Fountain Ministry Baptist Church decides to move elsewhere, infill could be removed and the storefront could be restored by adding plate glass display windows and a more period appropriate entrance. The second floor could remain apartments.

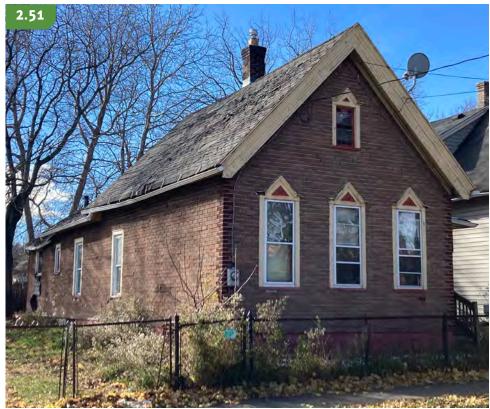
199 Lewis Street			
		HISTORIC ADDRESS	83 Lewis Street
CURRENT OCCUPANT	Private home	DATE OF CONSTRUCTION	c.1900
BUILDING TYPE	Historic House	ZONING	Marketview Heights Urban Renewal District / R-2 Medium Density Residential
BUILDING DESCRIPTION	This charming one-and-a-half story gable front house is sided with distinctive brick patterned asphalt shingles. Its roof has a steeper pitch than many other houses of a similar size, shape and age, and the windows are topped with triangular pediments. There is simple wooden decoration under the gable.		
STATEMENT OF SIGNIFICANCE	199 Lewis Street is significant as an intact example of early 20th century working class housing, with an unusual detailed asphalt shingle siding. It is particularly notable on a block that has experienced a significant number of demolitions.		
RECOMMENDATIONS	Priority Level 1: Retain building as an important contributor to the Lewis Street streetscape and as an impressive, intact example of historic housing in the neighborhood.Priority Level 2: Explore funding assistance opportunities for owner occupants of properties such as this. Roof will require attention soon.

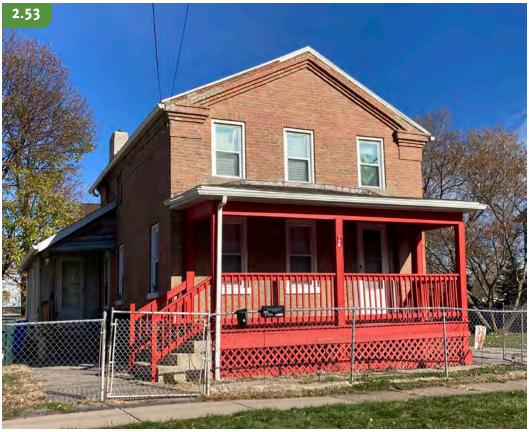
24 Ontario Street			
		HISTORIC ADDRESS	N/A
CURRENT OCCUPANT	Private home	DATE OF CONSTRUCTION	c.1860
BUILDING TYPE	Historic House	ZONING	R-2 Medium Density Residential
BUILDING DESCRIPTION	24 Ontario Street is a two story, gable front, Greek Revival style, brick house. The façade features a non-historic full width entrance porch and there is a smaller side entrance. The windows have been replaced, but otherwise the building is relatively intact. It features decorative brick corbeling along the cornice and cornice returns.		
STATEMENT OF SIGNIFICANCE	24 Ontario is significant as one of the earliest houses in the neighborhood and one of just a few Greek Revival style houses remaining in the neighborhood. It is also notable as an example of the style executed in brick.		
RECOMMENDATIONS	 Priority Level 1: Retain building as an important contributor to the Ontario Street streetscape and as an impressive, intact example of historic housing in the neighborhood. Priority Level 2: Explore funding assistance opportunities for owner occupants of properties such as this.

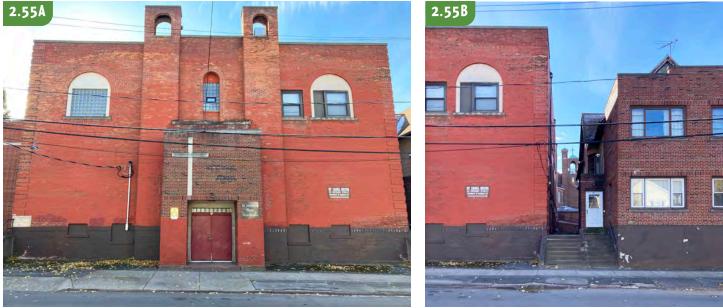
Notable Individual Properties			NATIONAL REGISTER ELIGIBLE
55 Ontario	55 Ontario Street /		
60 Woodwa		HISTORIC ADDRESS	55 Ontario Street
CURRENT OCCUPANT	Redeeming Word Christian Center Former Our Lady of Mount Carmel campus	DATE OF CONSTRUCTION	1909, 1920, 1929, 1940
BUILDING TYPE	Historic houses of worship Historic school building Historic rectory and convent Historic house	ZONING	C-2 Community Center
BUILDING & SITE DESCRIPTION	There are several buildings on this (1) Facing Ontario Street is the orig school after construction of the se building's facade was significantly (2) Facing Ontario St, to the east of brick convent with flat roof. This building. It retains its original meta coping above second story window (3) Facing Ontario Street, to the we Anne style house with an early 20th on the front elevation. This building (4) Facing Woodward Street, the se front gabled roof, Romanesque and tower. Buttresses line the side elev	ginal house of worship, w cond house of worship f altered/rebuilt after a fire f the first church is a Mid uilding remains remarkat I awning windows, concr vs. est of the first church is a h century, two story, brick g served as the rectory. econd house of worship. d Mediterranean Revival	acing Woodward Street. The e in 1955. -Century Modern style, two story, oly intact for a Mid-Century Modern rete entrance surround, concrete two-and-one-half story Queen s, flat-roofed apartment addition An impressive brick church with

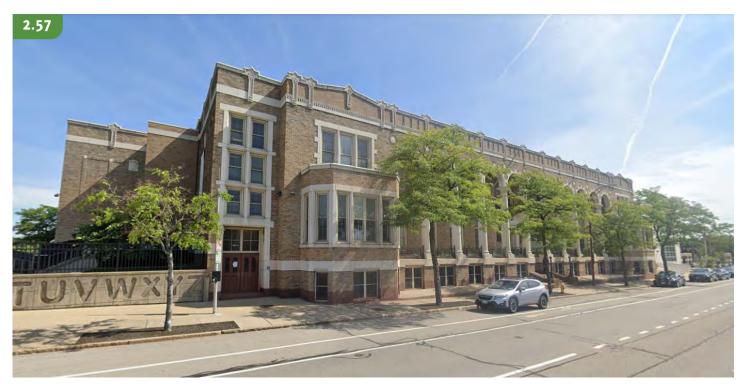
REGISTEN
200 University Avenue		HISTORIC ADDRESS	N/A
CURRENT OCCUPANT	City of Rochester World of Inquiry School No. 52 / Chester Dewey School No. 14	DATE OF CONSTRUCTION	1915-1916
BUILDING TYPE	Historic school	ZONING	R-2 Medium Density Residential
BUILDING DESCRIPTION	The school is an impressive two-story brown brick structure on a stone foundation with a two-story arcade that includes alternating stone and brick decorative architectural elements and Tuscan columns.		
STATEMENT OF SIGNIFICANCE	As stated in the 1985 National Register Nomination - The Chester Dewey School is architecturally significant in the neighborhood and the City of Rochester as an unusually distinguished example of early twentieth century public school design. Designed by prominent Rochester architect Edwin S. Gordon and built between 1915 and 1916, the eclectic design freely combines elements and details inspired by the Italian Renaissance including its eleven bay loggia, its finest and most unusual feature. It is the only historic public school building to survive the construction of the Inner Loop. The school was built to accommodate the city Normal School and School No. 14, its connected practice school.

RECOMMENDATIONS	Continue to use and maintain this building for community-serving purposes.

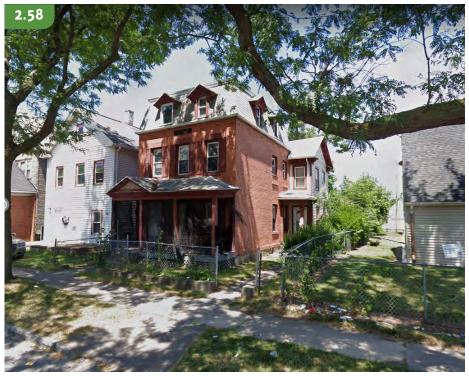
18 Weld Street			
		HISTORIC ADDRESS	N/A
CURRENT OCCUPANT	Private home	DATE OF CONSTRUCTION	c.1865
BUILDING TYPE	Historic house	ZONING	R-2 Medium Density Residential
BUILDING DESCRIPTION	18 Weld Street is a three story, 19th century, brick house with a mansard roof and a full width front porch. With Colonial Revival style detailing, the porch is an early 20th century alteration. A sign centered above the second floor windows reads "Jasper Huffman 1865 - [date illegible]". There is a later addition on the rear of the building which increases the square footage and turns the original rectangular plan into a T-shaped plan with a cross hipped roof. It is currently being used as a three family residence.		
STATEMENT OF SIGNIFICANCE	This building is architecturally significant as a rare example in the neighborhood of a house with a mansard roof. The original house was likely one of the earlier houses in the neighborhood, most likely constructed in the 1860s. The mansard roof appears to be a later alteration.

RECOMMENDATIONS	Priority Level 1: Retain building as an important contributor to the Weld Street streetscape. Priority Level 2: Explore funding assistance opportunities for owner occupants of properties such as this.

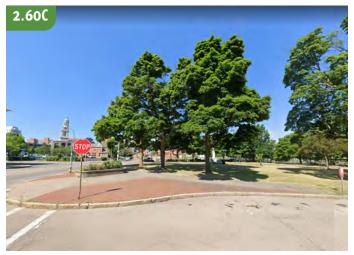
Present-day Schiller Park

Franklin Square / Schiller Park			
		HISTORIC ADDRESS	Corner of Franklin and Andrews Streets 350 Andrews Street (Current)
BUSINESS NAME	City of Rochester Schiller Park (previously Franklin Square / Franklin Park)	DATE OF CONSTRUCTION	Opened 1826
PHYSICAL DESCRIPTION	Prior to the construction of the Inner Loop, Franklin Square was bounded by Cumberland Street to the north, Andrews Street to the south, with Chatham Street terminating at the north end of the park, and Ormond Street terminating at the south end. Buildings (mostly residential), including the Jewish Young Men's Association faced the west and east sides of the park. It had curved pedestrian paths and numerous trees. The current Schiller Park is a small, roughly rectangular park bounded by the Inner Loop to the north, Andrews Street to the south. What remains of Franklin Square's east bounding street provides access to parking for the adjacent Rochester Municipal Archives & Records. The west bounding portion of Franklin Square now dead-ends into the Inner Loop and appears to be used for storage or staging of City building materials. What was once the center of an active neighborhood is now an underutilized remnant not easily accessible from any nearby residential uses.

RECOMMENDATIONS	When the Inner Loop North is removed, Franklin Square can and should be restored to its original size and layout. Doing so will create a much-needed large public green space, which can once again serve as a center of the community.

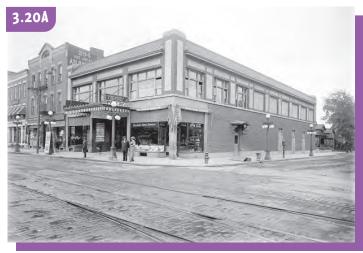
North Street at Lyndhurst Street, facing east

accommodate all methods of transportation, including streetcars. The black and white photo on this page shows the tracks down the center of the street, with lanes for automobile traffic on either side (*Figure 3.20A*). The color photo below shows a different view of the street today (*Figure 3.20B*). Without the streetcar tracks, the right-ofway is wide enough to accommodate two lanes of traffic in either direction, which yields a street that is wide enough for bicycles and automobiles, but may be too wide for the comfort of crossing pedestrians.
